DEPARTMENT OF TRANSPORTATION

Contract #: 04-0120F4Cty: SF/ALA Rte: 80 PM: 13.2/13.9File #: 82.28**WELDING INSPECTION REPORT****Resident Engineer:**Siegenthaler, Peter**Address:** 333 Burma Road**City:** Oakland, CA 94607**Report No:** WIR-019901**Date Inspected:** 21-Jan-2011**Project Name:** SAS Superstructure**OSM Arrival Time:** 700**Prime Contractor:** American Bridge/Fluor Enterprises, a JV**OSM Departure Time:** 1300**Contractor:** Westmont Industries**Location:** Santa Fe Springs, CA**CWI Name:** Ruben Dominguez**CWI Present:** Yes No**Inspected CWI report:** Yes No N/A**Rod Oven in Use:** Yes No N/A**Electrode to specification:** Yes No N/A**Weld Procedures Followed:** Yes No N/A**Qualified Welders:** Yes No N/A**Verified Joint Fit-up:** Yes No N/A**Approved Drawings:** Yes No N/A**Approved WPS:** Yes No N/A**Delayed / Cancelled:** Yes No N/A**Bridge No:** 34-0006**Component:** Travelers**Summary of Items Observed:**

WELDING INSPECTION REPORT

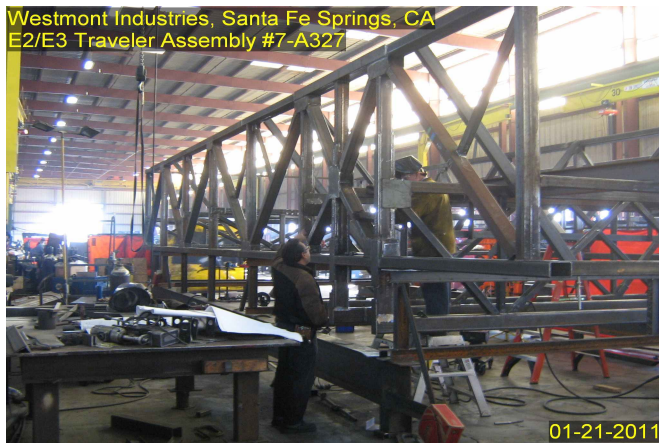
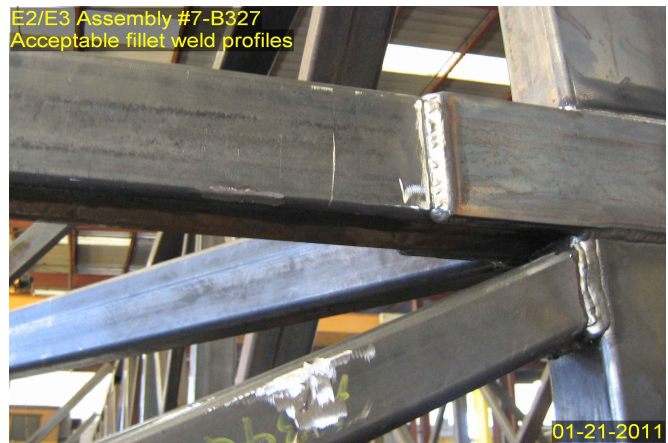
QA observed in-process FCAW welding and performed random visual inspection of completed welds. QA noted no non-conforming items. Please see photographs below.
